# **Institute on Lake Superior Geology**

**40th Annual Meeting  
May 11-14, 1994**

**Part 5—Lessons from mining case histories:  
West Menominee Range, Michigan**

*By: Allan M. Johnson*

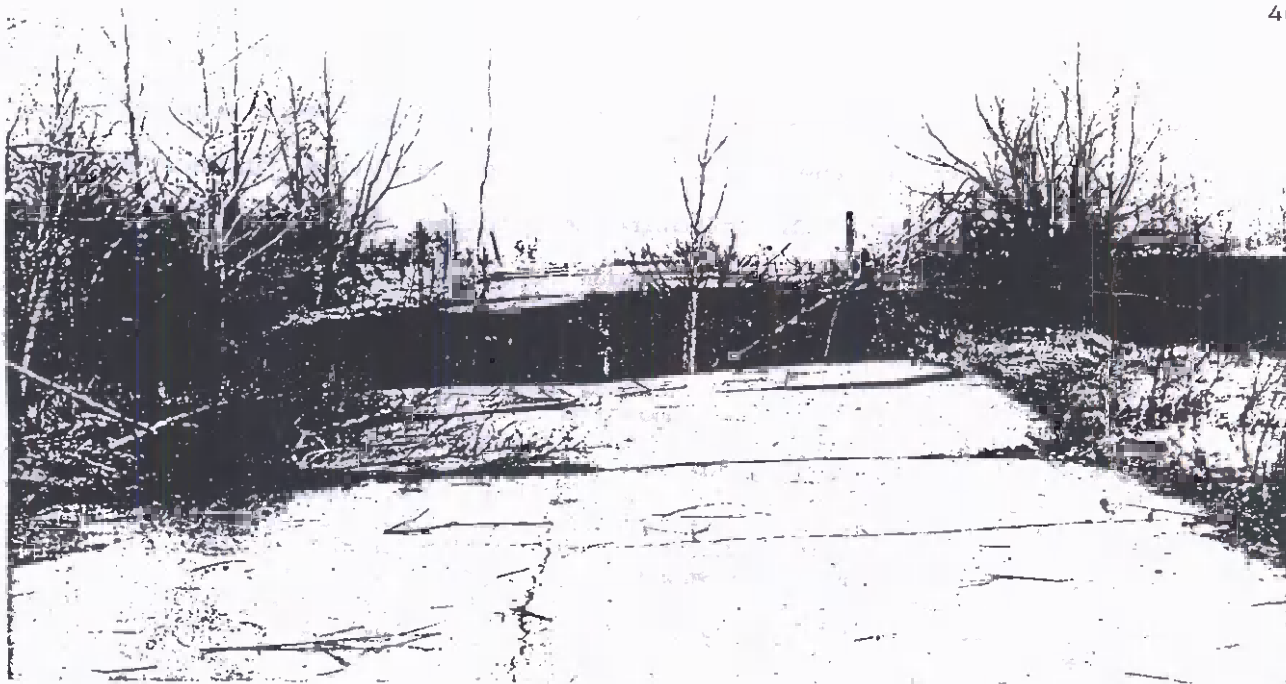
Figure 18. Smuggler Mine Cave-in on County Road 424: Looking East
